PROJECT:
PENTHOUSE STAIRWAY
 (TENANT IMPROVEMENT)
 1600 Telegraph Ave.
 Oakland, CA 94612

PROJECT INFORMATION:
ROOF PLAN

A-2.3

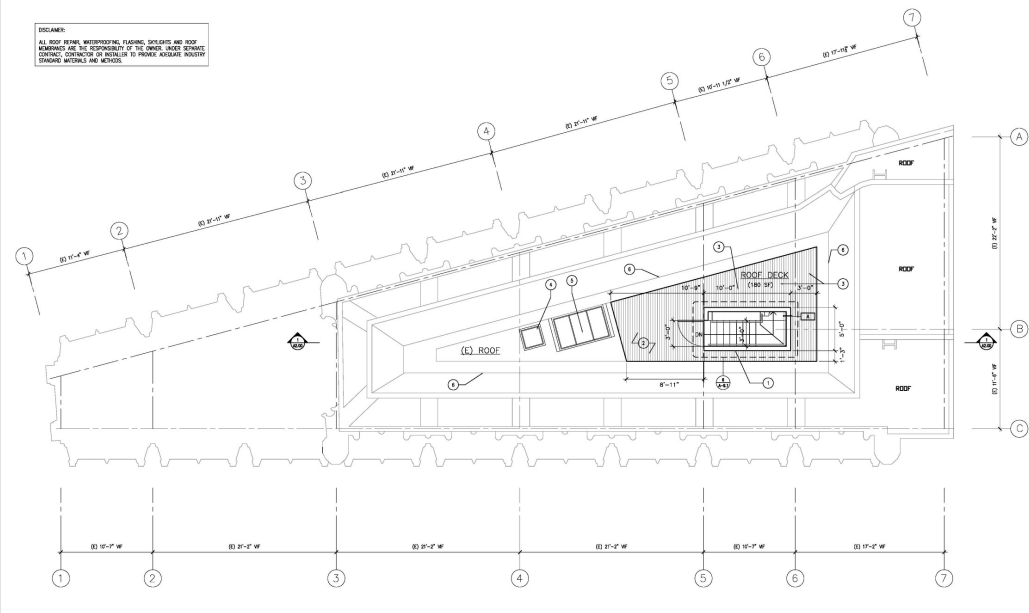
1 ROOF PLAN
 SCALE: 1/4" = 1'-0"

- 1 (N) EXIST ENCLASURE WITH CONCRETE BOARD EXTERIOR PAINT TO MATCH (E) PANELS, SEE 3/A-15.1
- 2 (N) ROOF DECK G/ SLEEPERS, S.S.S.
- 3 FRIED/FLAT/ROOF OPENINGS IN ROOF MEMBRANE/ROOF SLAB AFTER LEAK OF (E) PINE/CORR AND PLUMBING VENTS
- 4 (N) FIBERGLASS DOWN ORANGE SKYLIGHT G/ (E) OPENING IN ROOF SLAB, SEE 4/A-15.1, PROVIDE CUT SHEET
- 5 (N) FRIED-INNEI SKYLIGHT G/ (E) OPENING IN ROOF SLAB, SEE 4/A-15.1, PROVIDE CUT SHEET
- 6 REPAIR PERIMETER FRAMER WALL, PAINT TO MATCH EXISTING
